NASA Contractor Report 4664

# Analysis of Materials Flown on the Long Duration Exposure Facility: Summary of Results of the Materials Special Investigation Group

*H. Gary Pippin*

*H. Gary Pippin*  
*Boeing Defense & Space Group • Seattle, Washington*

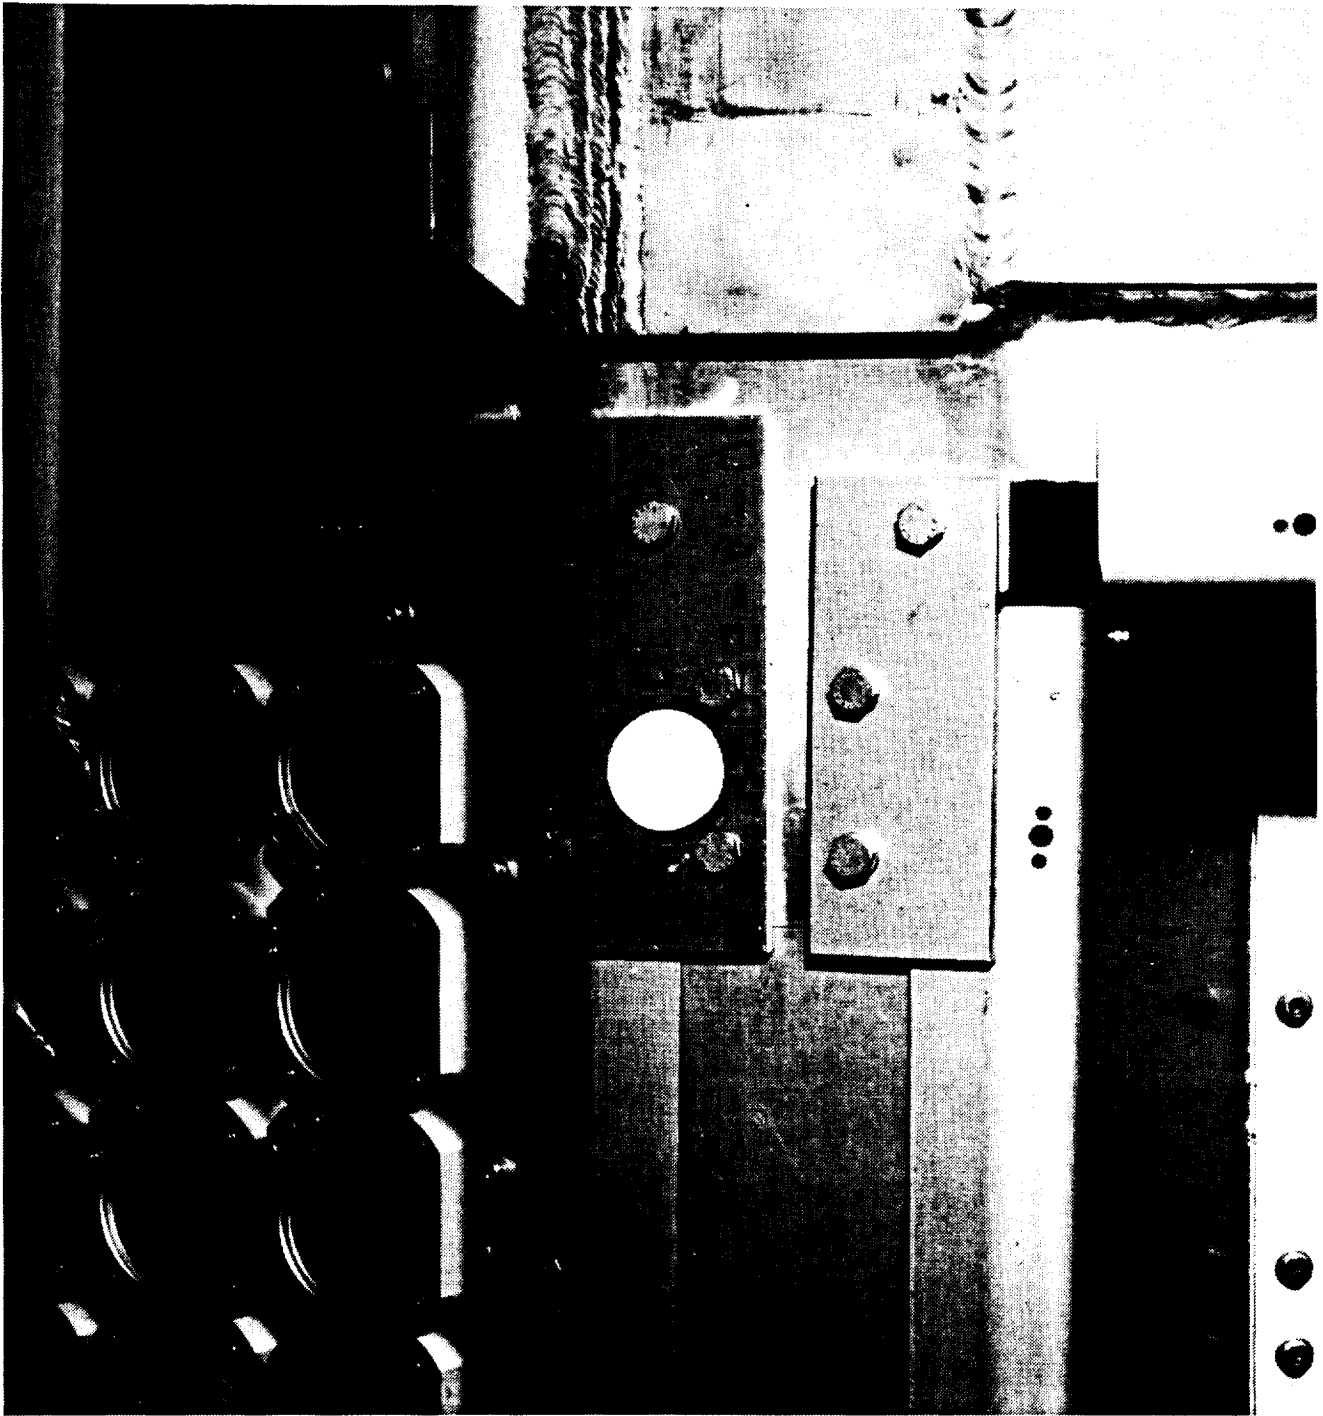
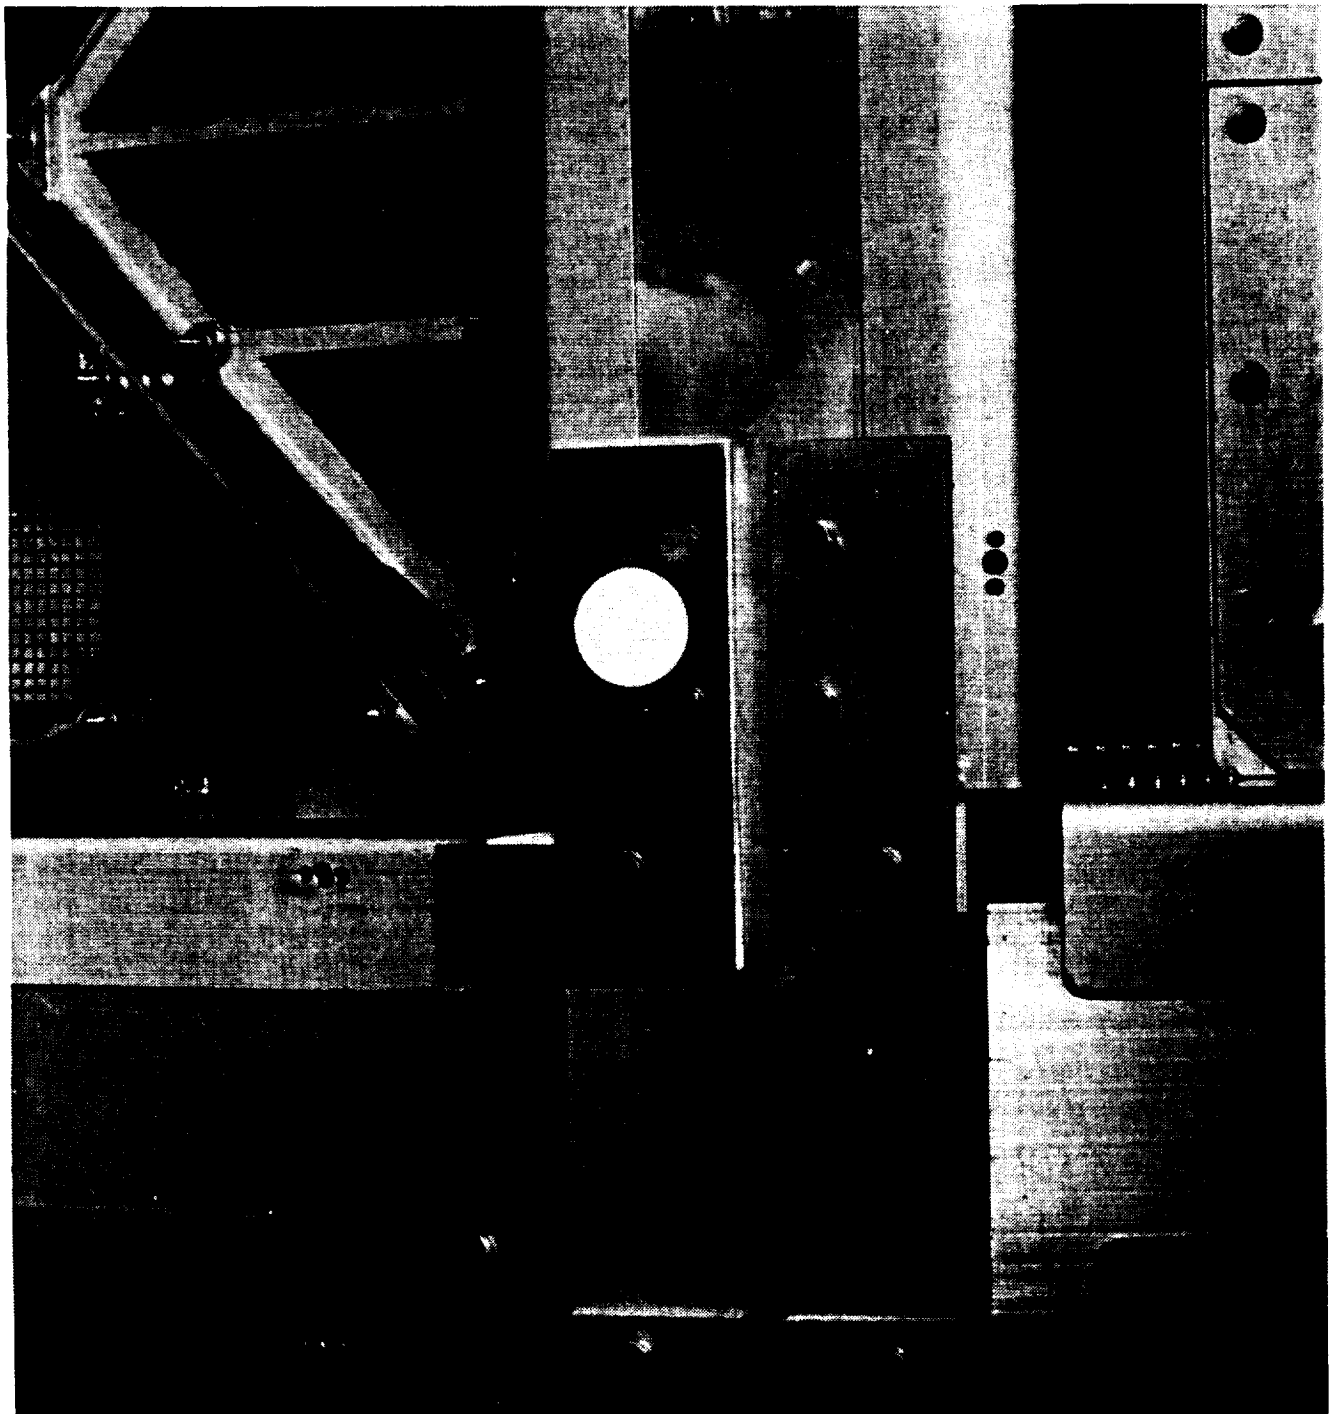
The leading edge exposed Z306 ring around the A276 paint button in figures 7.2-16 and 7.2-17 is almost completely removed. This erosion is even more severe than the erosion of the Z306 around other leading edge tray clamp paint buttons, such as is shown in figure 7.2-19. A possible explanation is that the temperature cycling on these unanodized clamp surfaces was greater than for the chromic acid anodized (CAA) clamps because of the poorer optical properties of the bare aluminum. The increased temperature relative to the anodized clamps would allow a faster reaction rate of the atomic oxygen with the paint. Any changes to the Z306 on the trailing edge clamps due to solar exposure were concealed by the black pigment in this paint. The chemical structure of the binder may have been altered, but this did not significantly affect the optical properties of the paint. Since these locations saw no atomic oxygen, there was no effective removal mechanism. The A276 paint button on the clamp in 7.2-18 shows the solar UV induced darkening of this paint due to binder damage. For typical trailing edge locations the absorptance of the A276 doubled. The absorptance and emittance values for selected clamps are compared in figure 7.2-20.

Figure 7.2-16. NASA post-flight photo of leading edge unanodized aluminum tray clamp at space end of C9. (Color figure C-27 rotated 180°)

Figure 7.2-17. NASA post-flight photo of leading edge unanodized aluminum tray clamp at Earth end of C9. (Color figure C-28 rotated 90°)

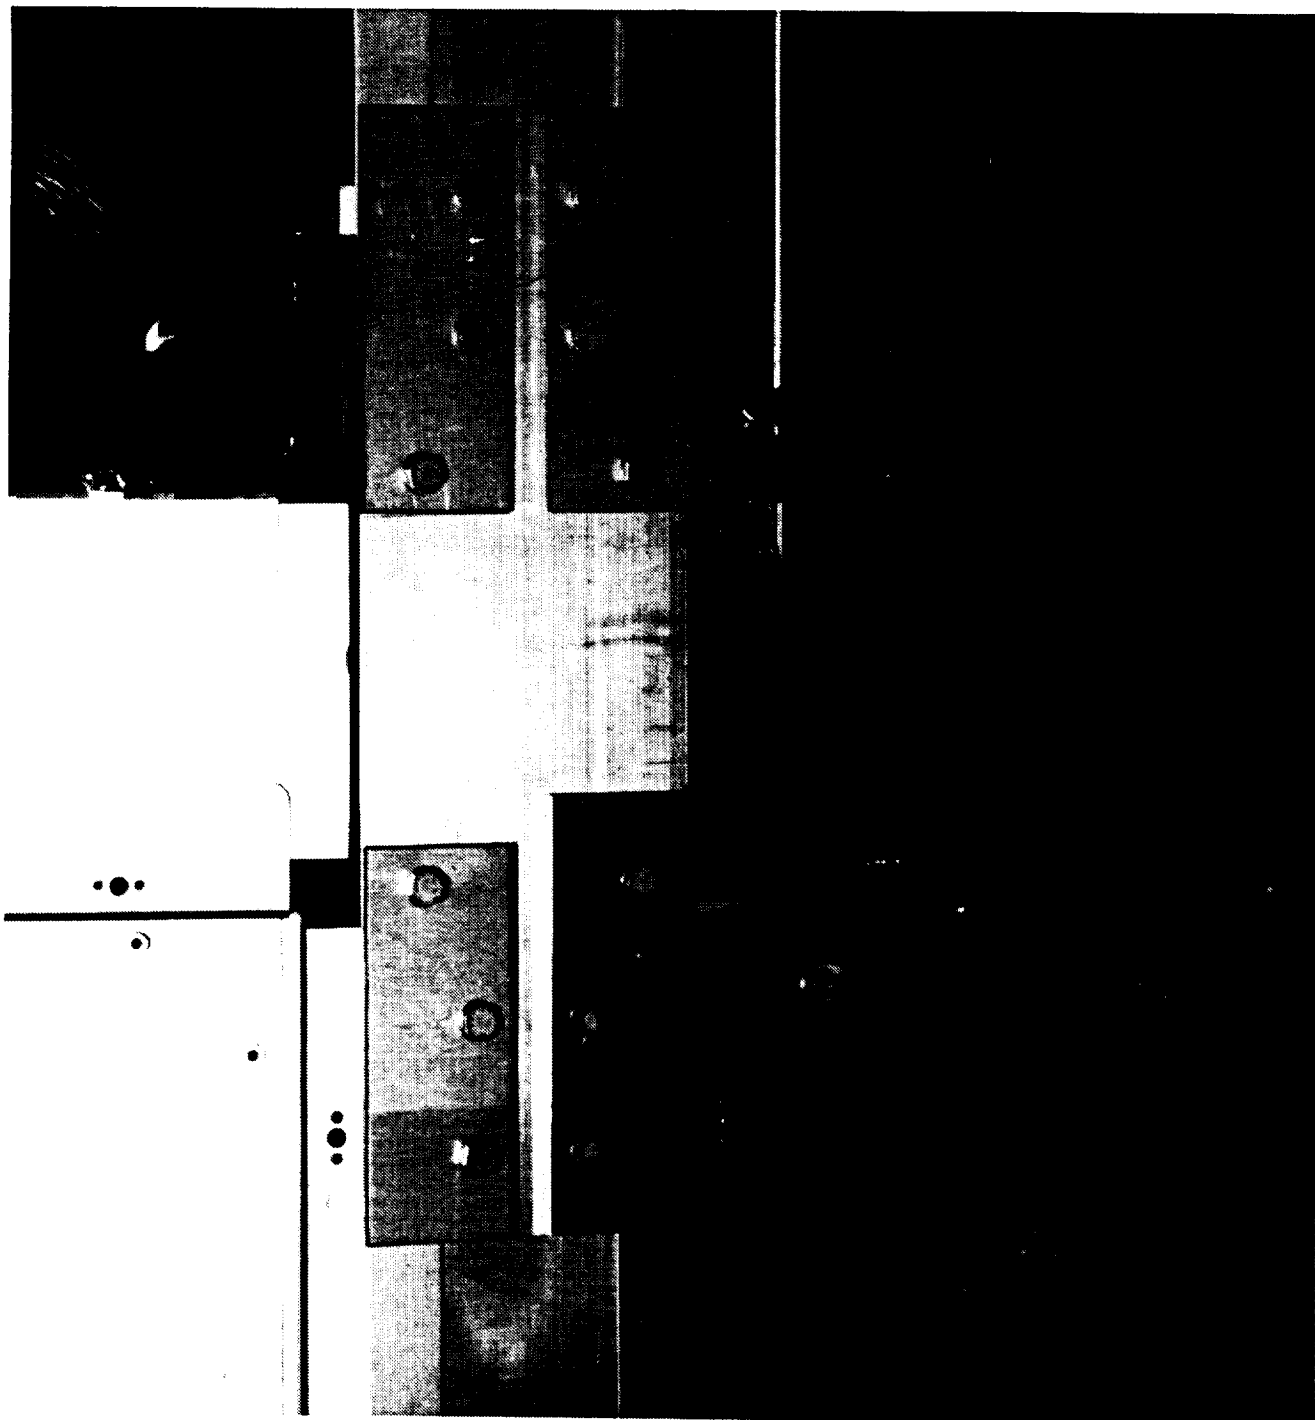
Figures 7.2-16 and 7.2-17 are photographs showing "L" shaped unanodized aluminum tray clamps from the leading edge. Figure 7.2-18 is a close-up photo of an "L" shaped unanodized trailing edge (C3) tray clamp with nearby anodized clamps, showing the darker color of the unanodized clamp. The appearance of each of the unanodized clamps was essentially unchanged by the flight exposure. These clamps were manufactured to provide extra support for trays C3 and C9. These trays were quite heavy and after the flight certification (vibration) test it was felt the additional support was needed to hold these trays in place. These clamps were not anodized for thermal control because of their relatively small surface area and time constraints. The "L" shaped unanodized tray clamps were manufactured just before the flight.

Figure 7.2-18. NASA post-flight photo of trailing edge unanodized aluminum tray clamp on tray C3. (Color figure C-29)

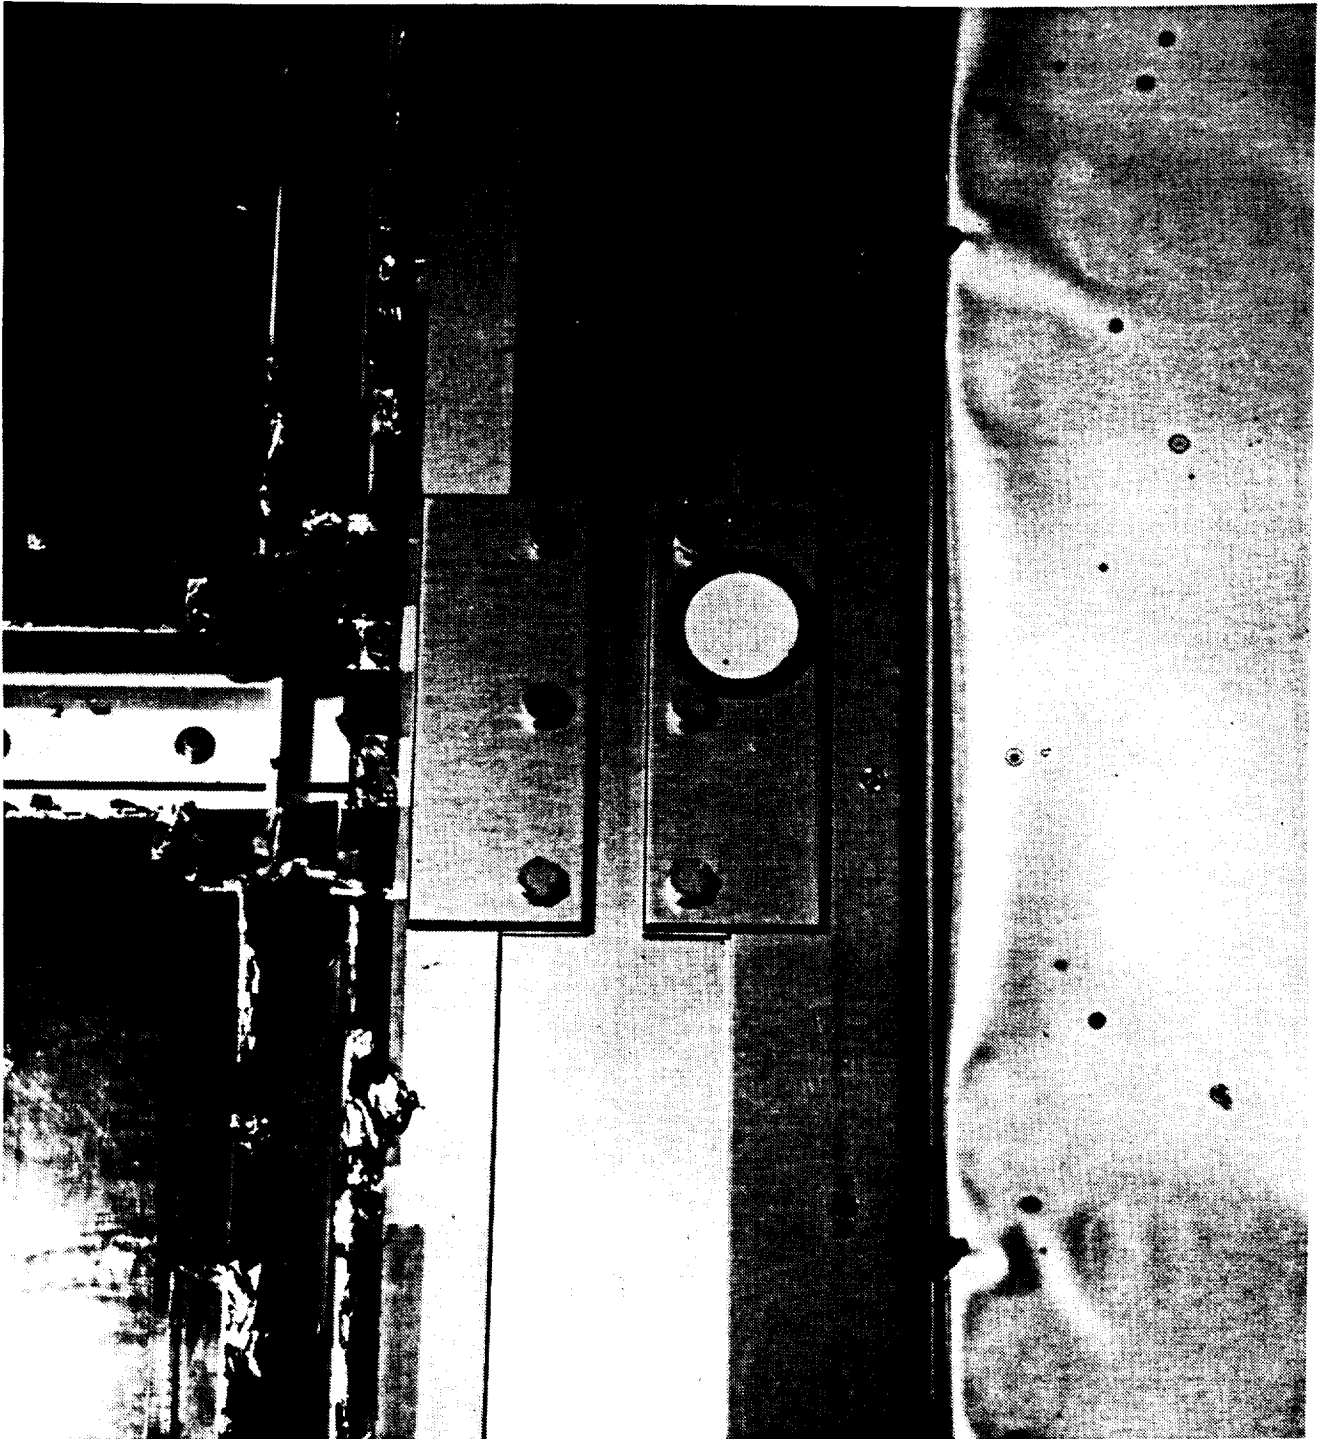
Figures 7.2-22 and 7.2-23 are photographs showing a leading (longeron between D10 and D11) and a trailing (longeron between C2 and C3) edge location, respectively. The paint button toward the leading edge remained white, but only the pigment remained. The trailing edge location shows a significant color change as the solar UV damaged the surface of the A276 paint binder. The photograph of the trailing edge location also shows rolled-up films of tantalum which failed mechanically during flight. The failure was likely caused by thermal-cycling-induced stresses.

Figure 7.2-22. NASA post-flight photo of leading edge tray clamp with paint button mounted between trays D10 and D11. (Color figure C-32)

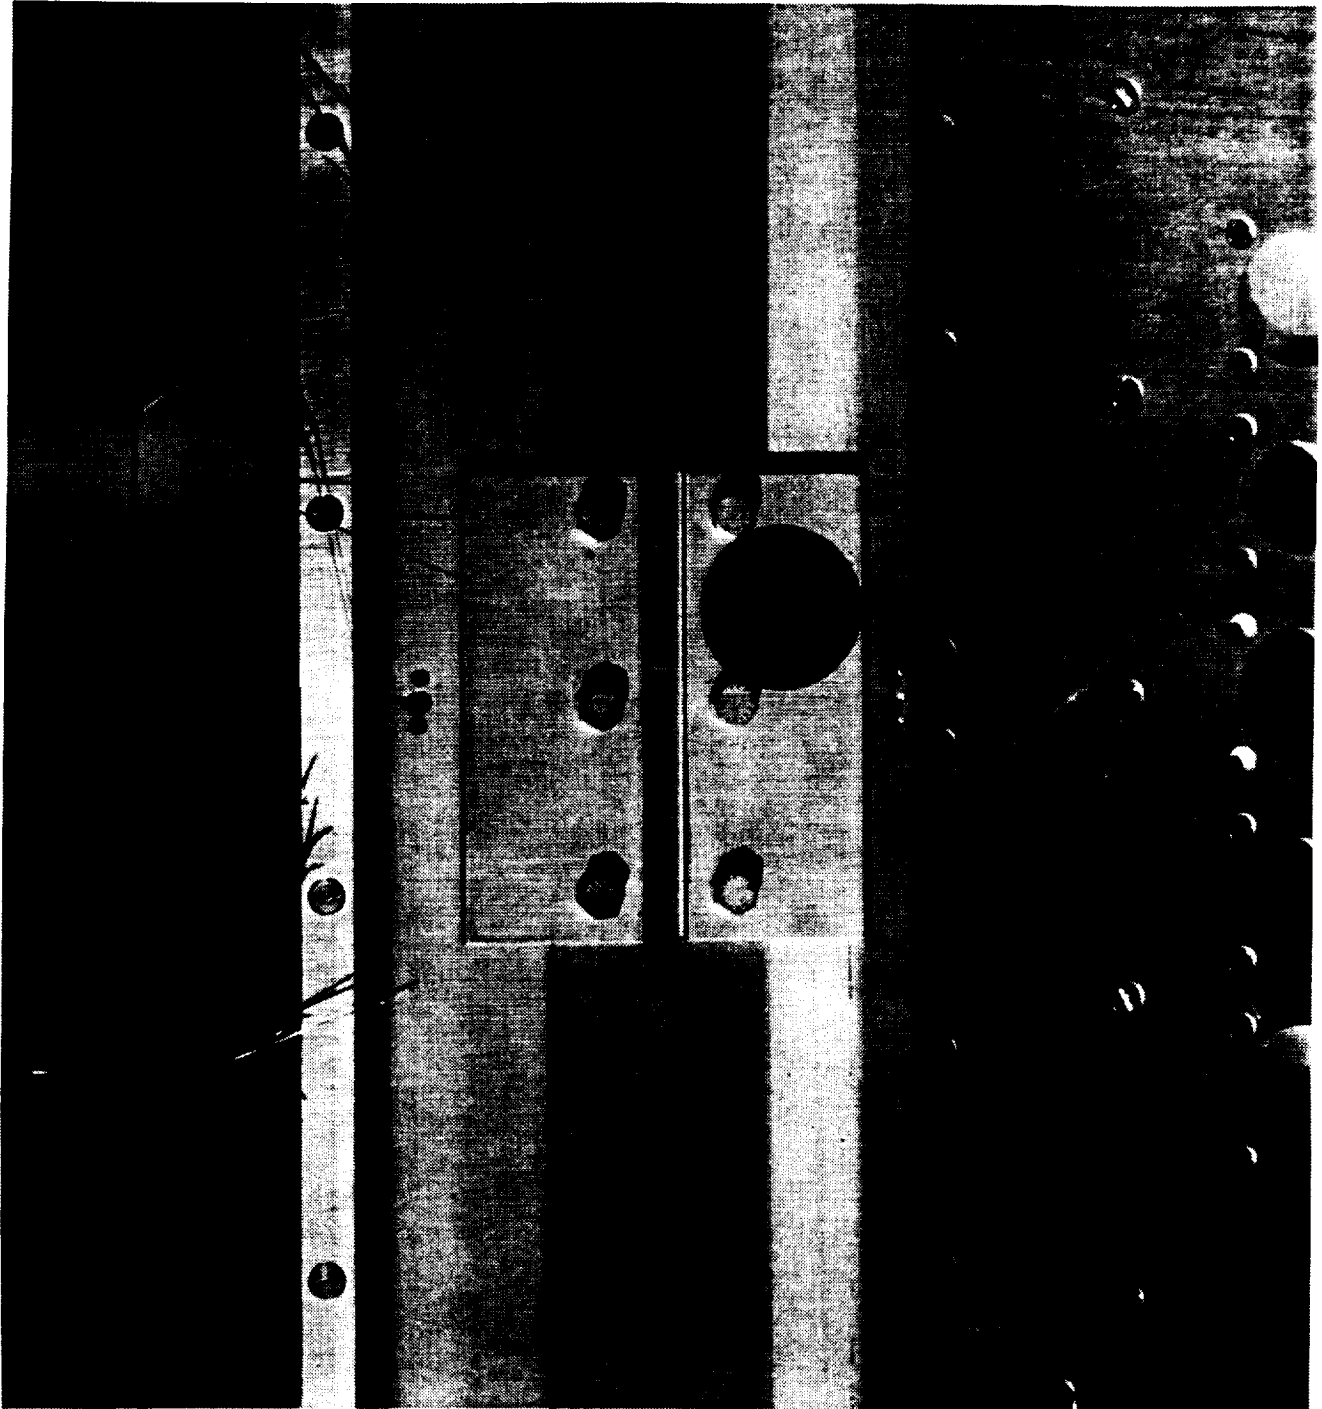
Figure 7.2-23. NASA post-flight photo of trailing edge tray clamp with paint button mounted between trays C2 and C3. (Color figure C-33)

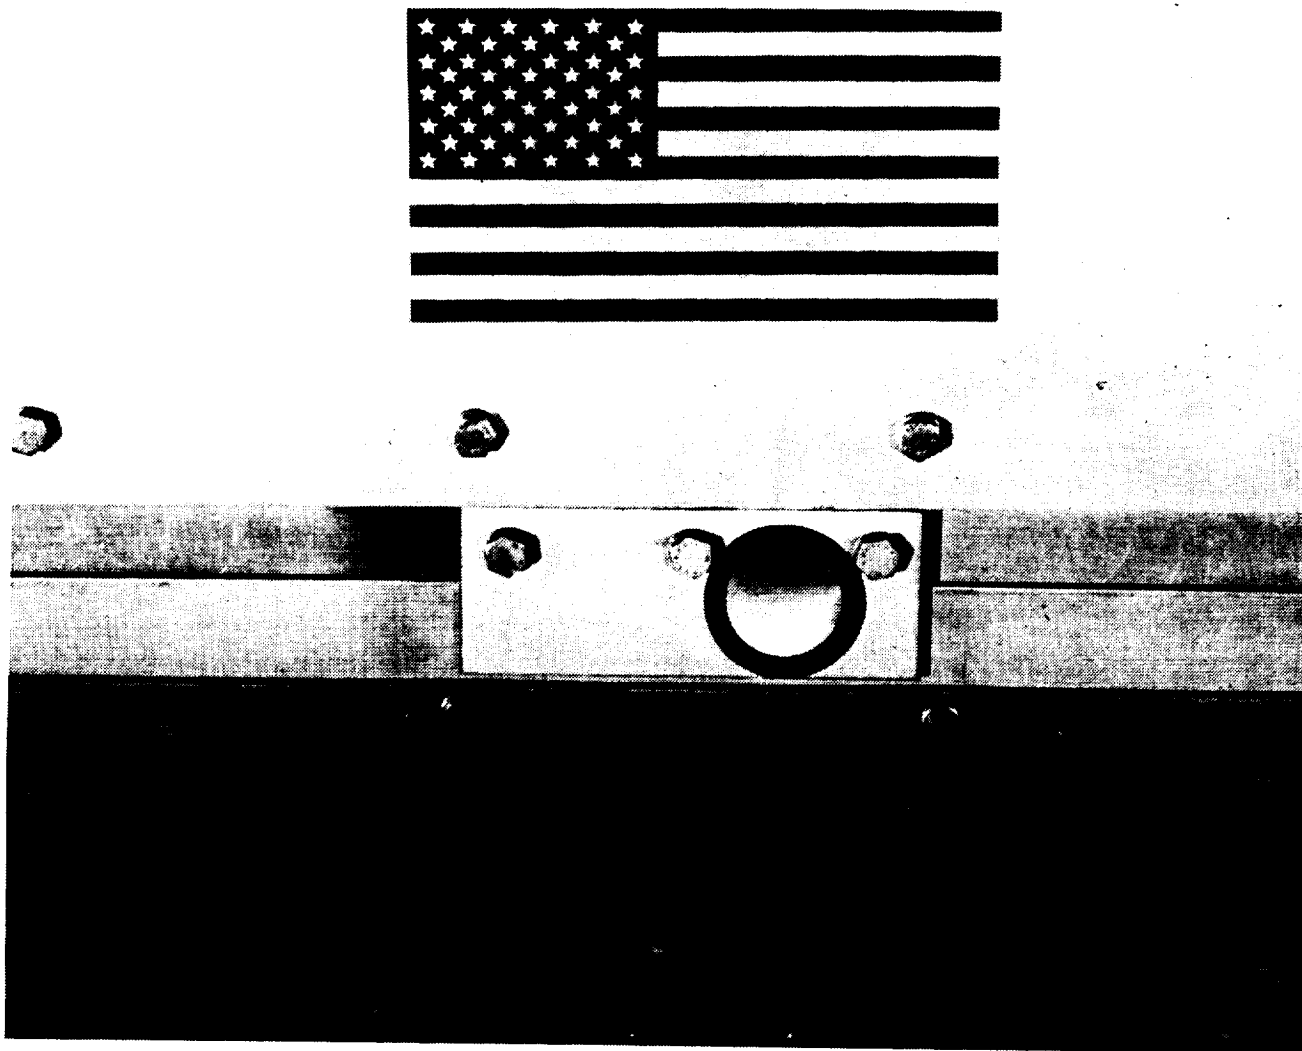
The space end photo in figure 7.2-24 shows the extreme directionality of impingement of atomic oxygen. The top portion of the paint button, shielded from AO, has darkened under UV exposure. The majority is white where it has been attacked by moderate amounts of AO. The ram exposure is a grazing angle incidence from the right. The flag is a decal applied just before the flight.

Figure 7.2-24. NASA post-flight photo showing detail of space end of LDEF showing blocking of ram atomic oxygen impingement on a paint button by a tray clamp bolt. (Color figure C-34).

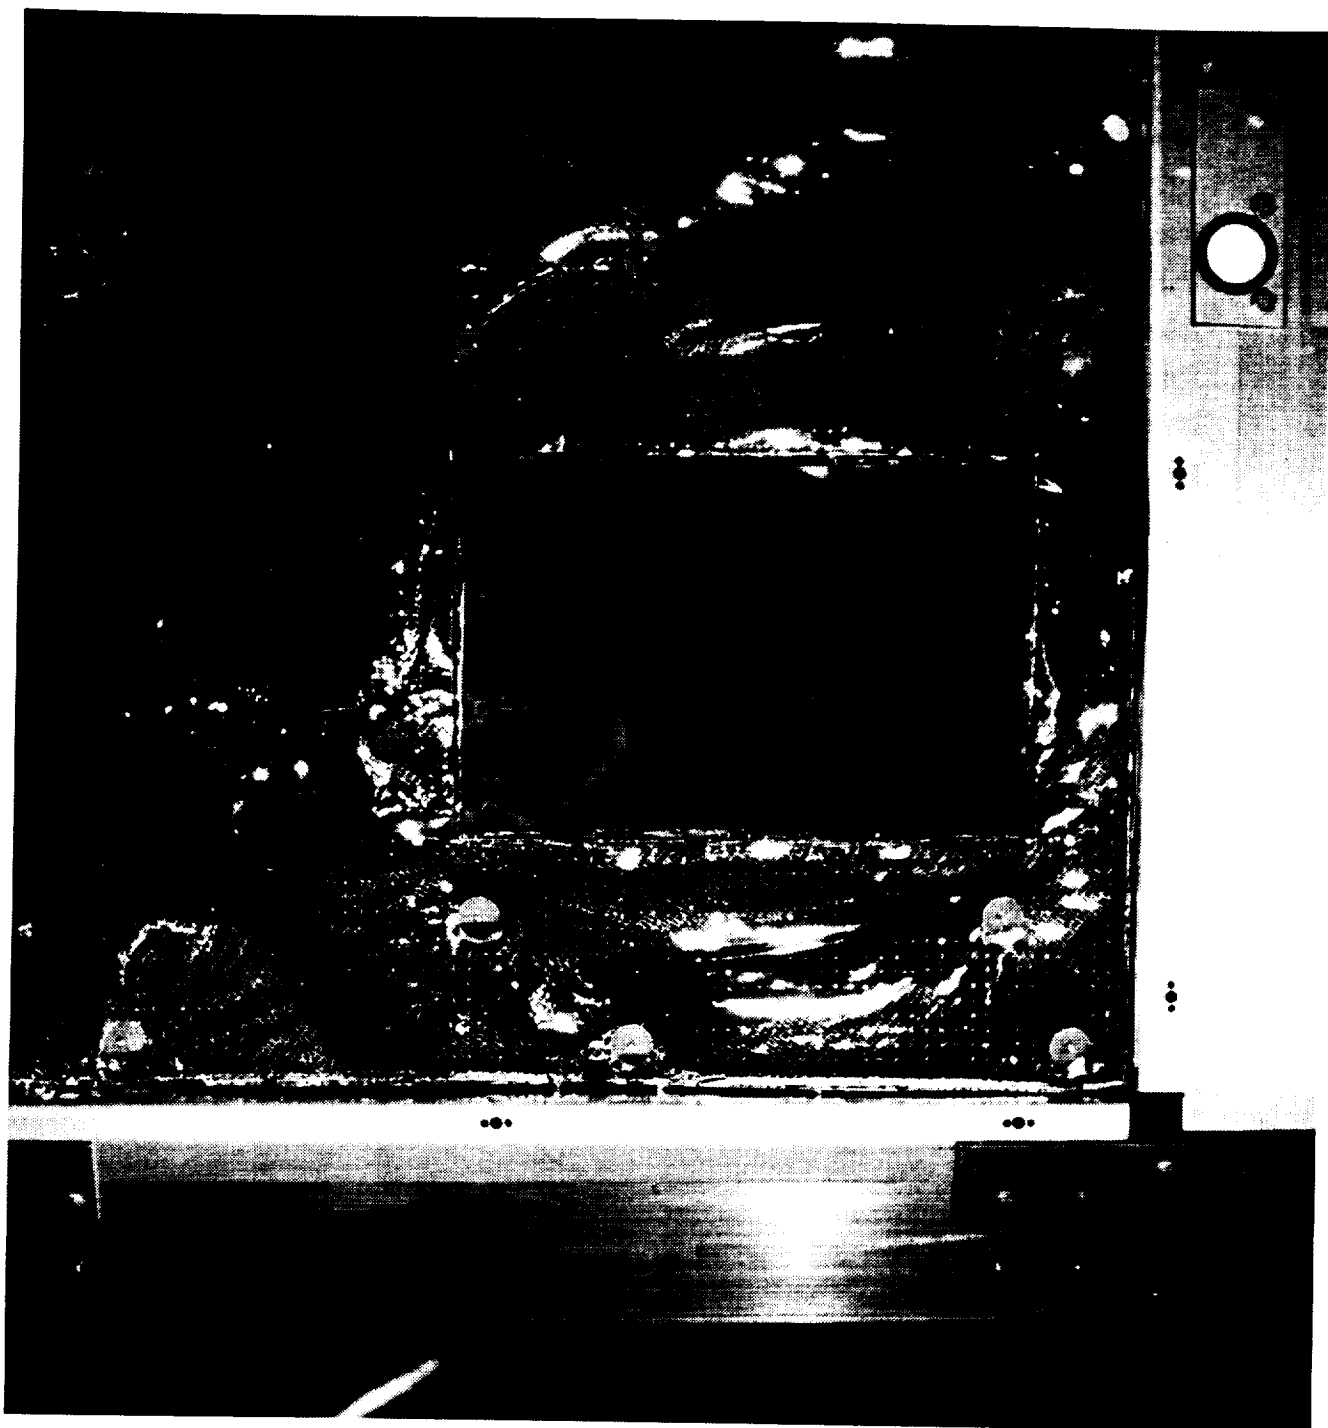
Figure 8.3-1. NASA post-flight photo of radiator panel from tray F9. (Color figure C-35 rotated 90°)

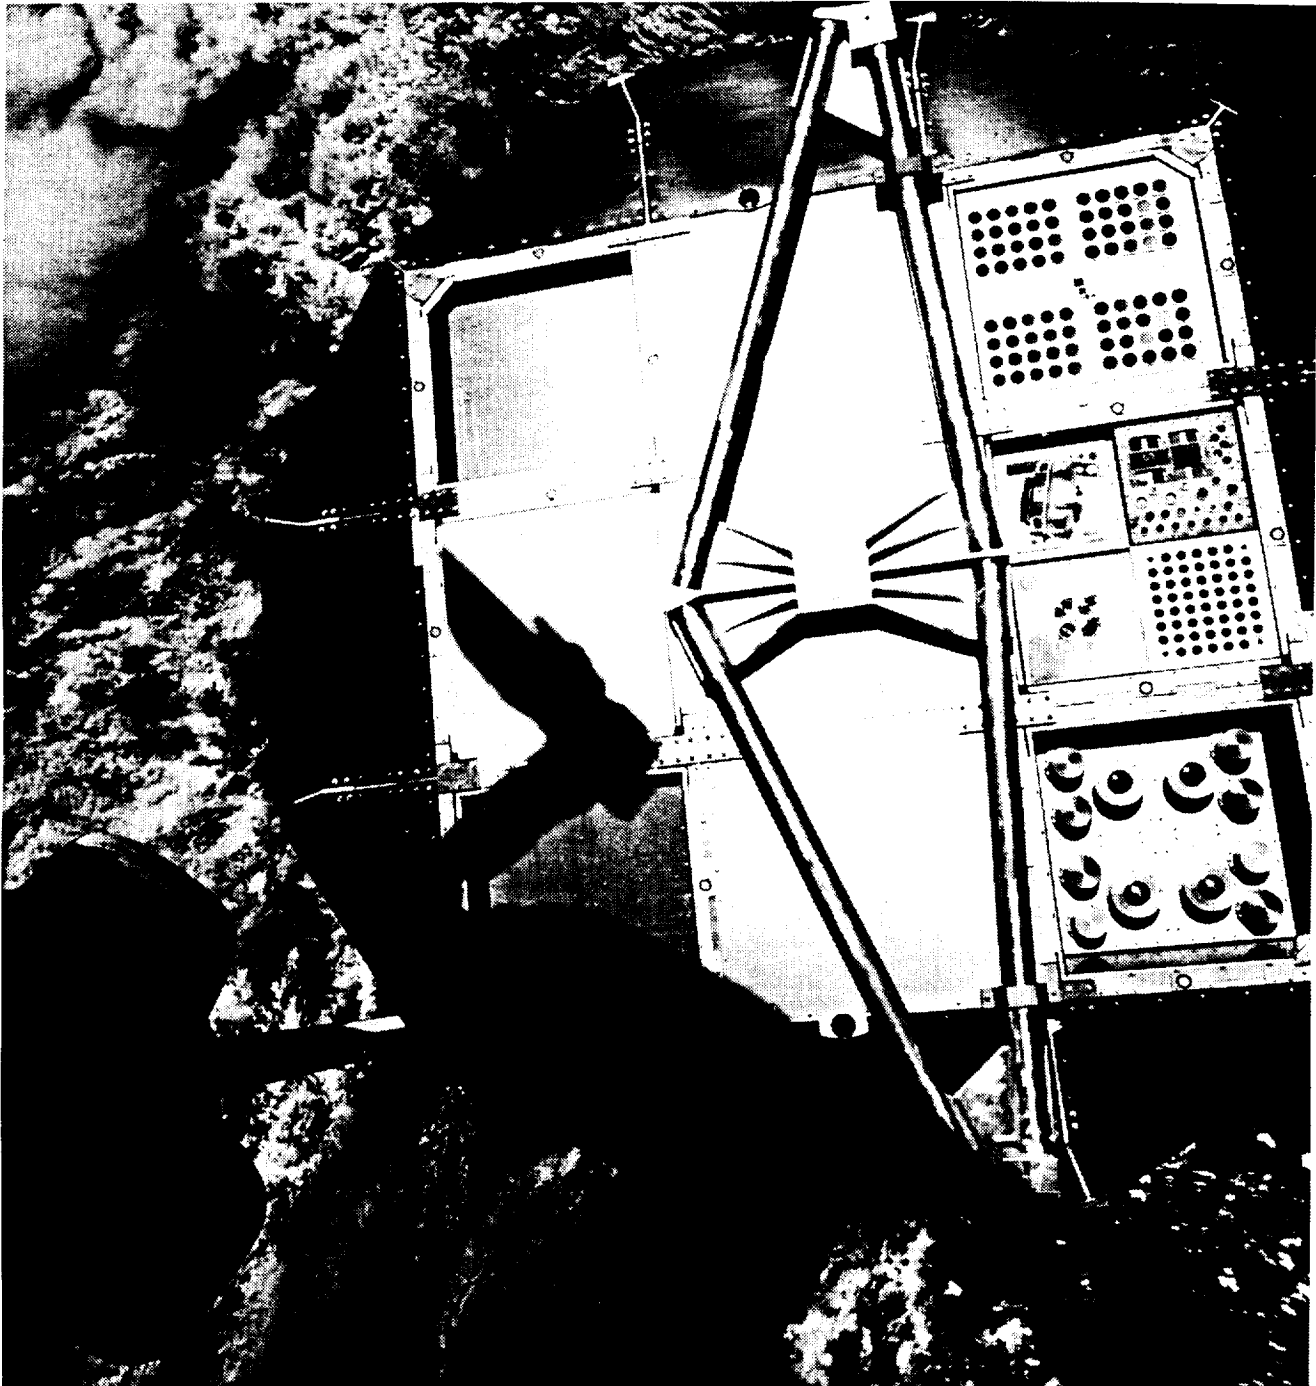
Two black chrome-plated panels from the Earth end, identified as 916-10A and 916-4A, were examined in several locations for comparison with the F9 plate. Figure 8.3-2 shows a NASA on-orbit photo of the Earth end of LDEF, including the black chrome panels of interest. The end panels have small ~4 inch wide sections bent at 90 degrees to the large, Earth-facing part of each panel. The small section on each plate overlays the Earth end intercostal for a particular row and is oriented with respect to the ram direction in the same manner as the particular row. This means that, in addition to the Earth-facing exposure, a continuous range of exposure conditions was experienced around the bend. One edge of panel 916-10A is on row 10, 22° from ram. Figure 8.3-3 shows the relationship between the angle around the bend in the panel, measured from the Earth facing end as 90°, and the angle from ram. Figure 8.3-4 shows the Earth-end panel (916-10A) with black chrome plate finish.

Figure 8.3-2. NASA on-orbit photo of Earth end of LDEF. (Color figure C-36)

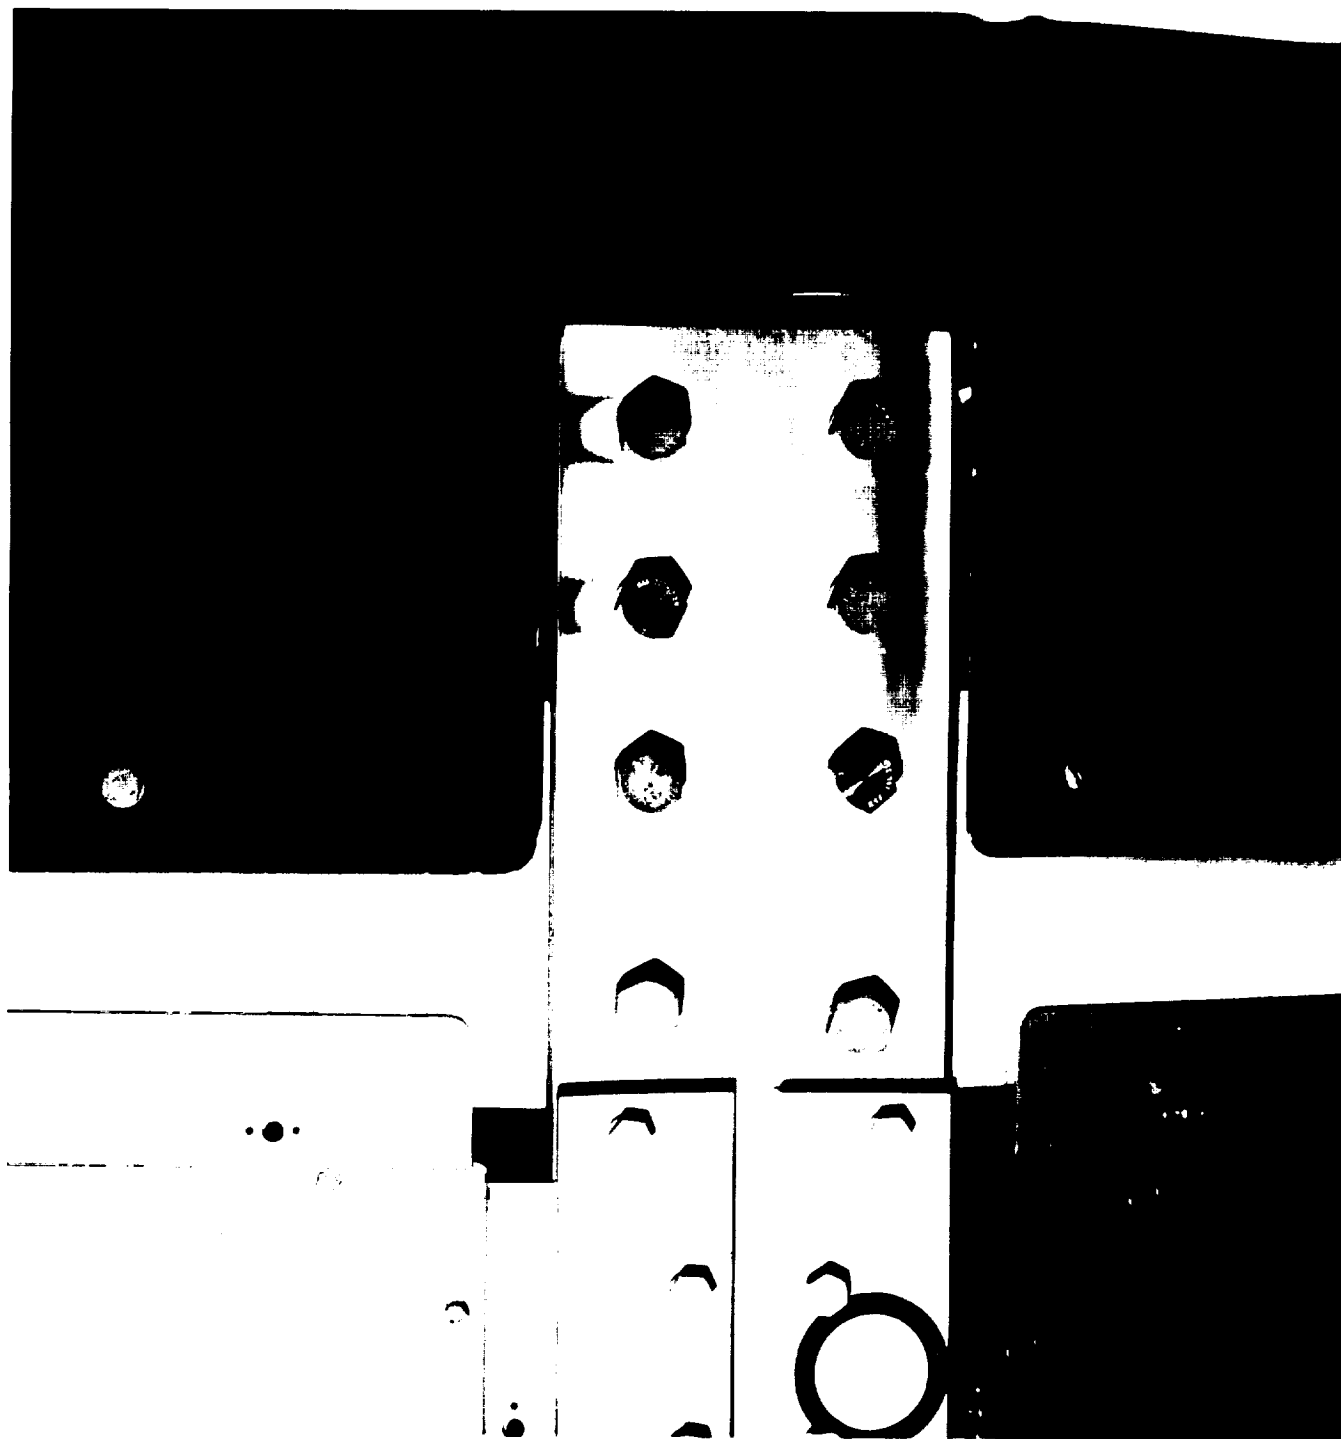
Figure C-15. NASA post-flight photo of contamination deposits on longeron between trays A11 and A12.

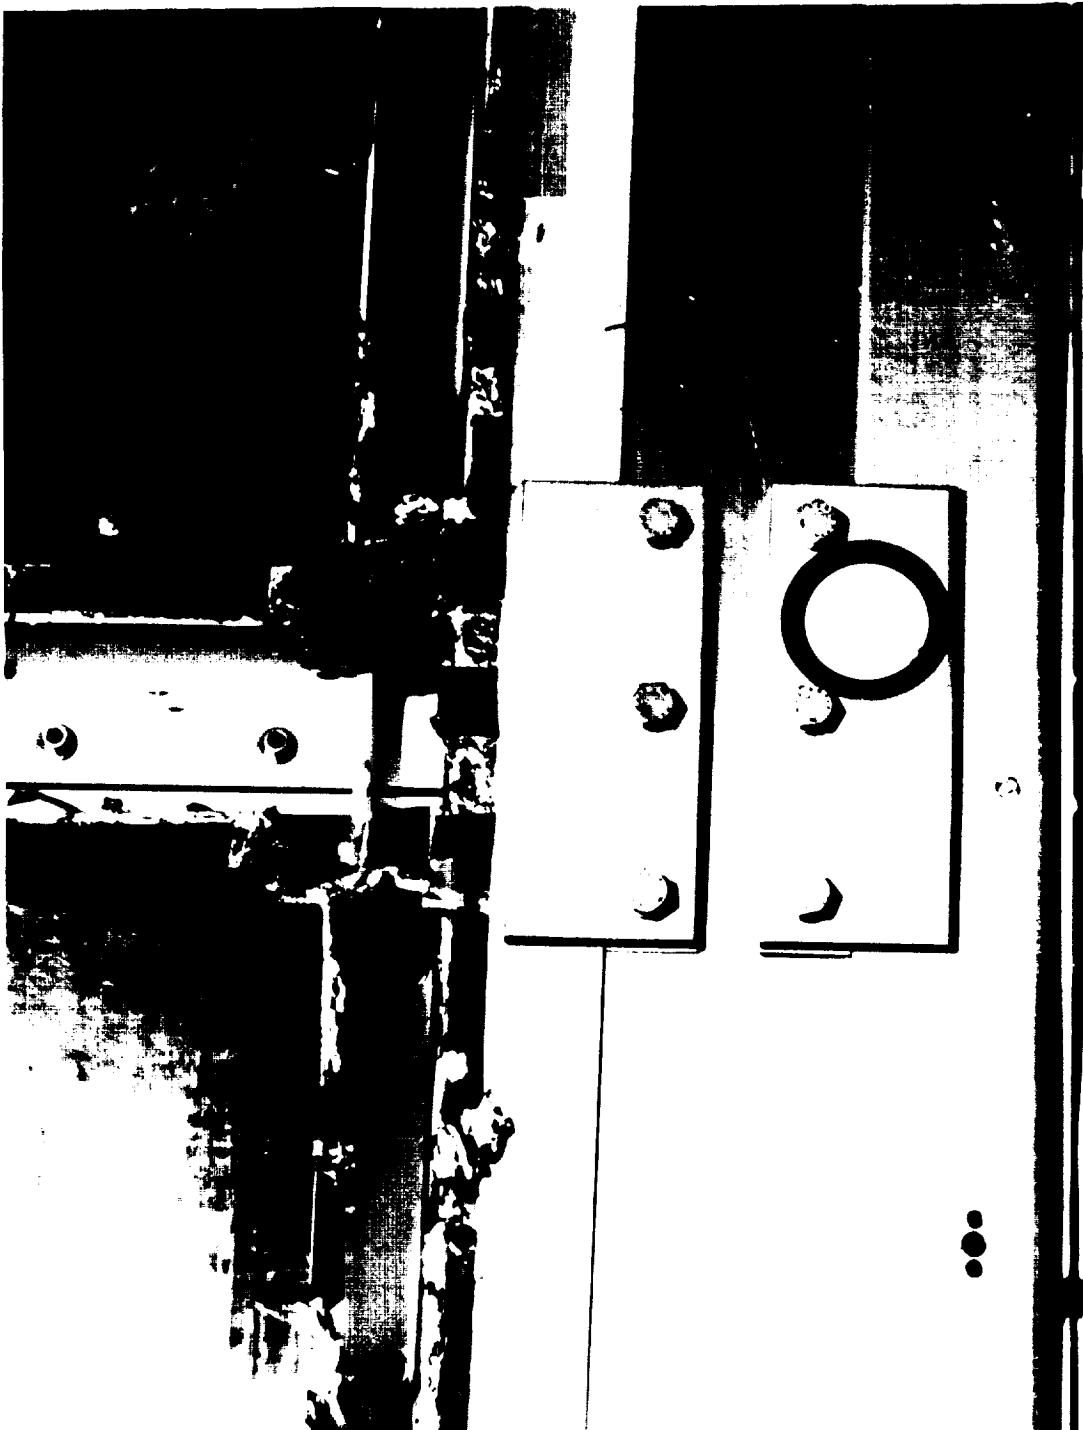
Figure C-32. NASA post-flight photo of leading edge tray clamp with paint button mounted between trays D10 and D11.

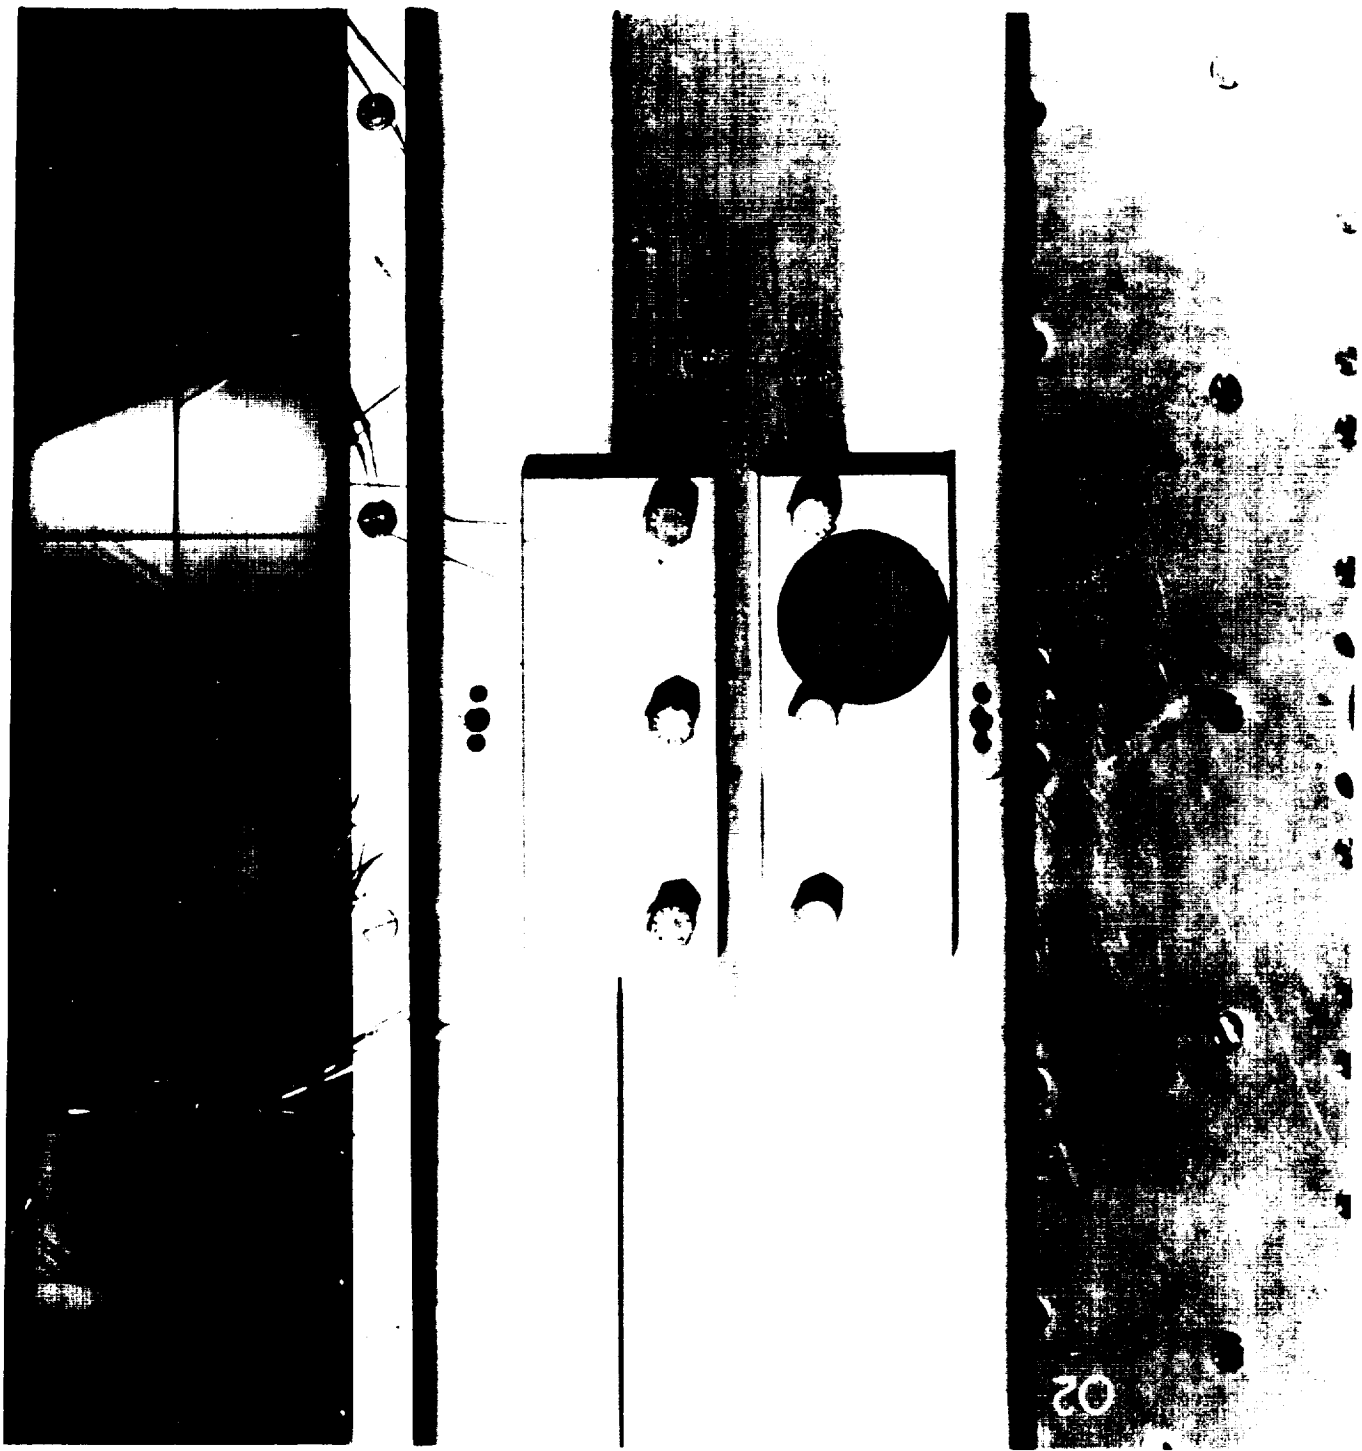
Figure C-33. NASA post-flight photo of trailing edge tray clamp with paint button mounted between trays C2 and C3.

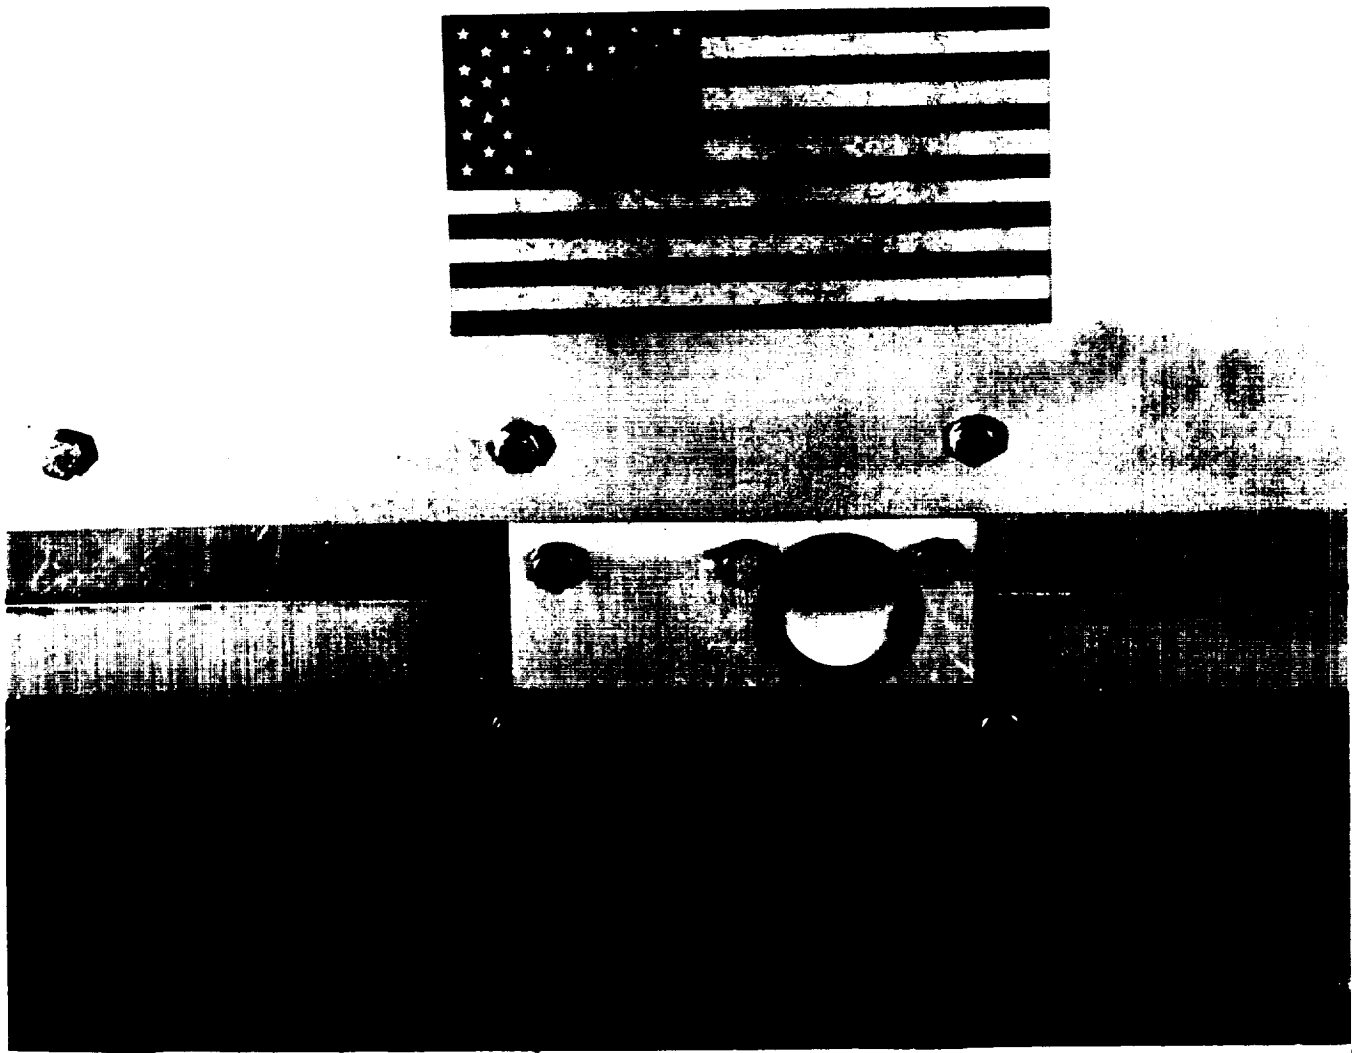
Figure C-34. NASA post-flight photo showing detail of space end of LDEF showing blocking of ram atomic oxygen impingement on a paint button by a tray clamp bolt .
